Home Inspection Report

Your New Home

03/16/2019

Porch Light Home Inspections
913-245-1110

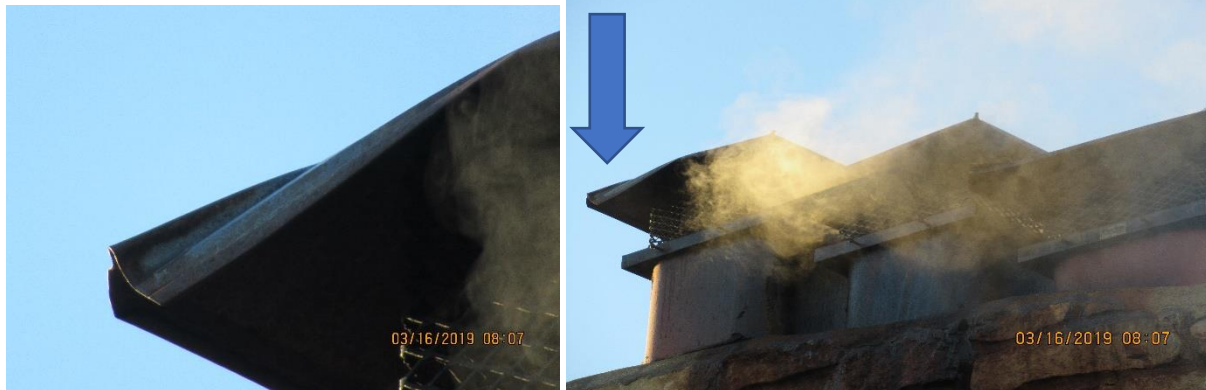
Chimney cover damaged. Recommend replacement.

One chimney cover damaged. Recommend replacement.

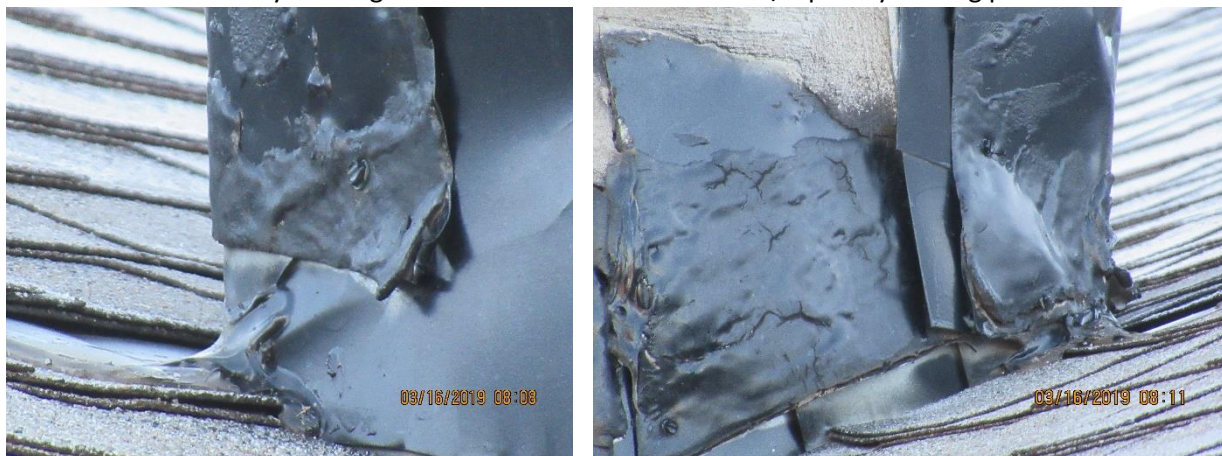
Chimney flashing appears to have minor voids. Recommend further evaluation by roofing professional. This is a moisture intrusion issue.

Minor voids in chimney flashing. Recommend further evaluation/repair by roofing professional.

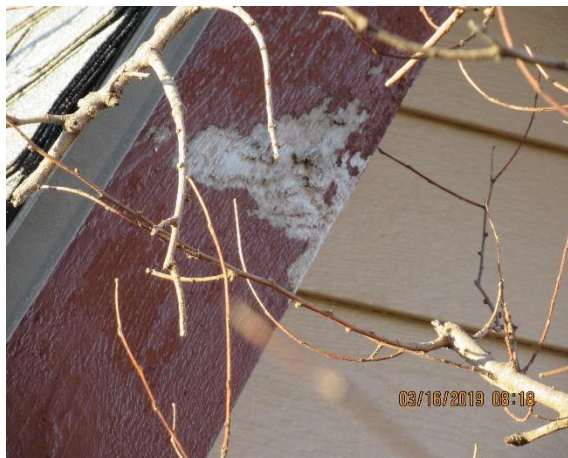
Fascia damaged by tree, north side of home. Recommend repair/repaint.

Fascia damaged by tree, north side.

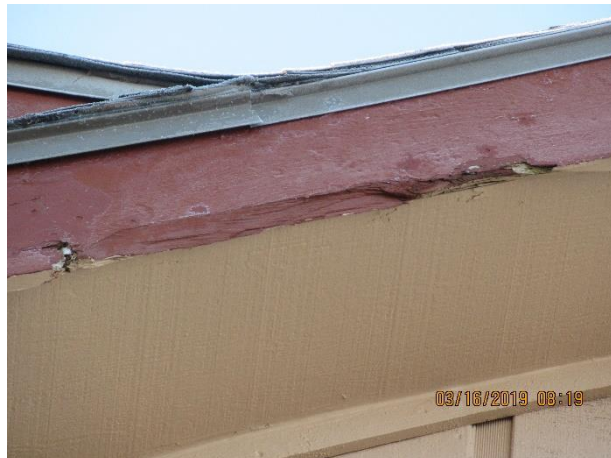
Fascia wood rot, damage, rear area near T.V. antennae. Recommend repair/replace.

Fascia wood rot, damage, rear area near T.V. antennae.

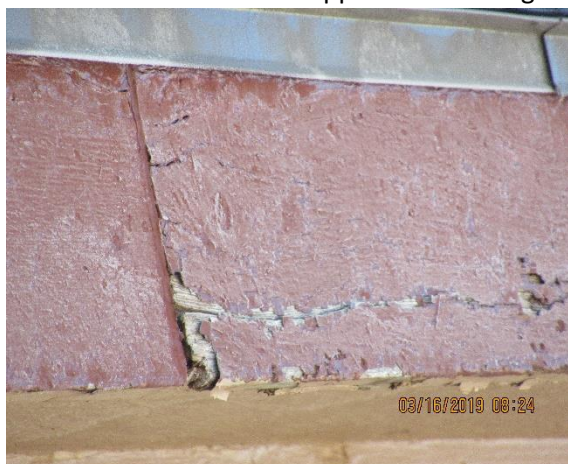
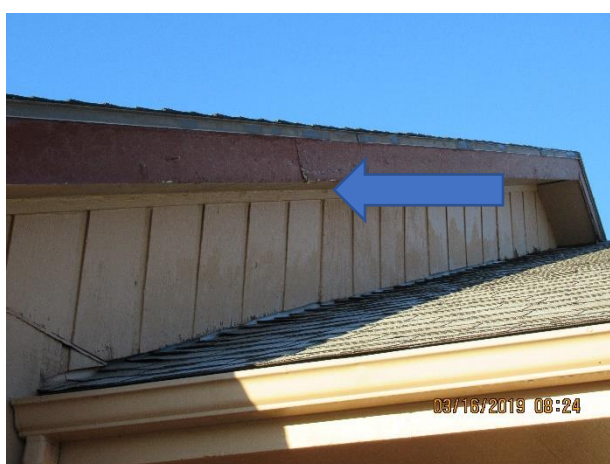
Upper level north gable fascia wood rot. Recommend repair/replace.

Upper level north gable fascia wood rot.

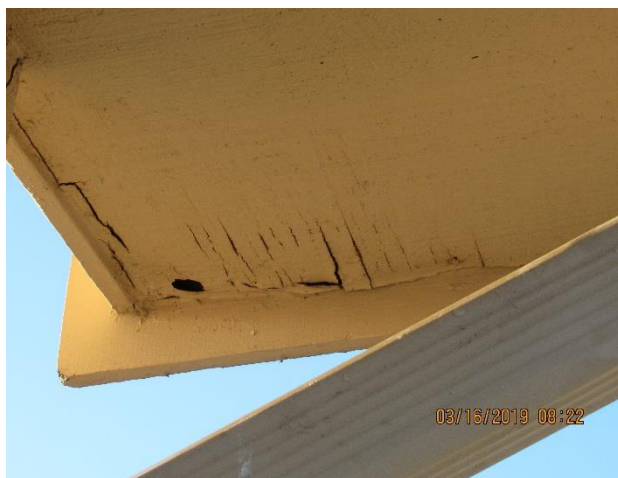
Southwest corner soffit wood rot. Recommend repair/replace.

Southwest corner soffit wood rot.

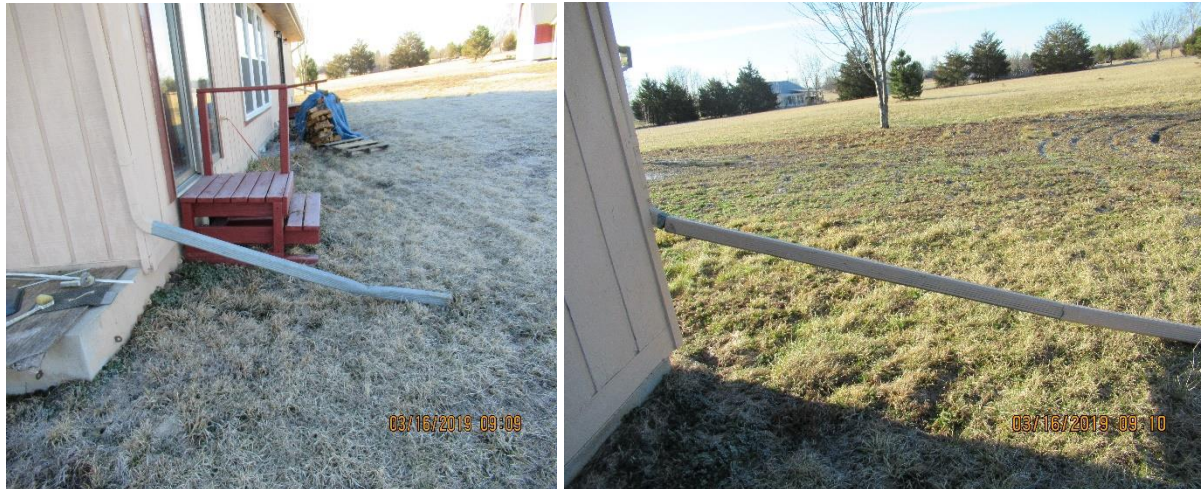
Downspout extensions on rear of home are not connected properly. Loose and inadequate.

All downspouts should have proper splash blocks and extensions to direct rain water away from the foundation.

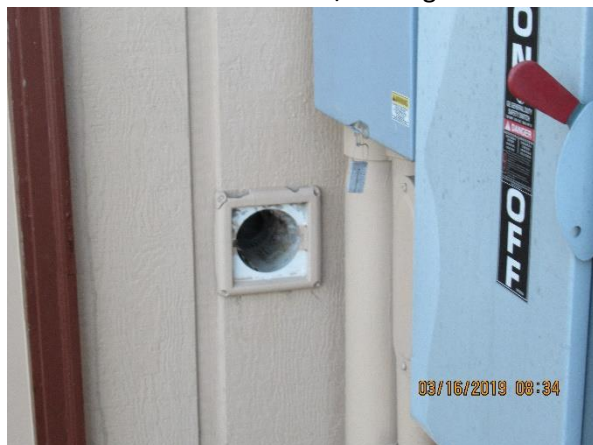
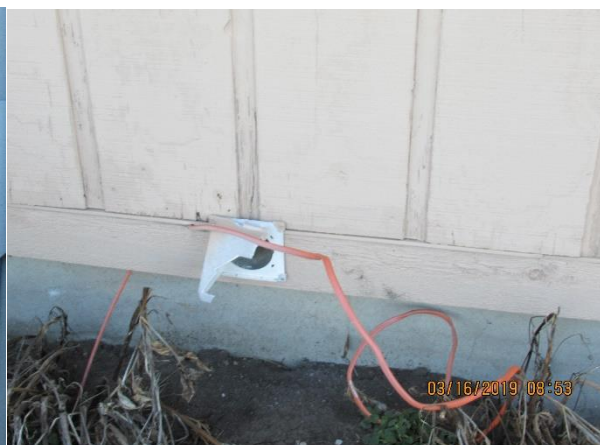
Exterior vent covers broken/missing. Recommend repair/replace.

Exterior vent covers broken/missing.

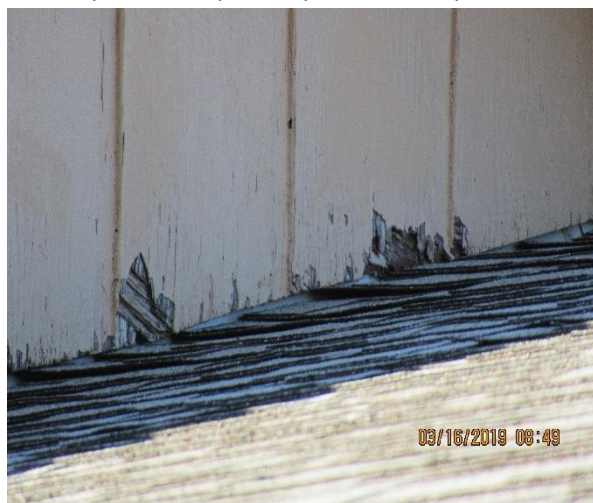
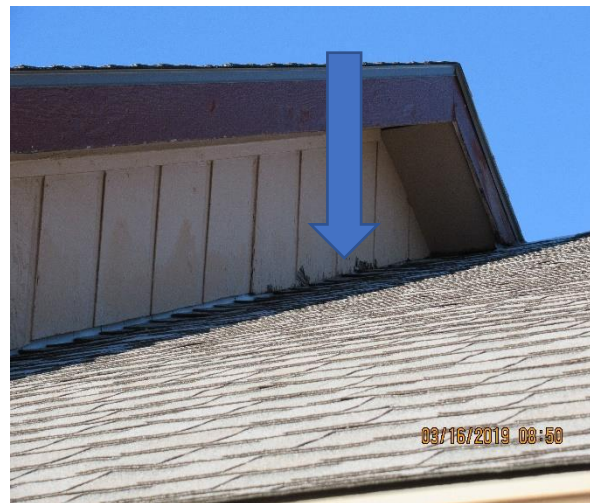
Siding damage/wood rot on upper level north gable. This damage goes completely through the siding to the attic. Likely caused by squirrels or woodpeckers. This should be repaired promptly as it is giving birds, insects and squirrels access to the attic interior.

Siding damage/wood rot on upper level north gable. This damage goes through to the attic interior. Possibly caused by woodpeckers or squirrels.

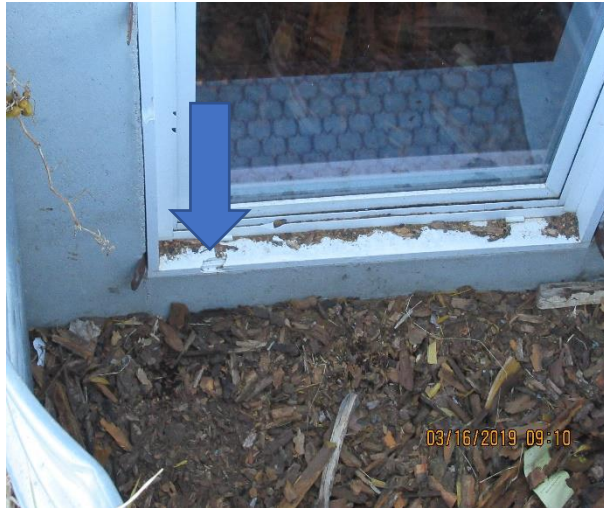
Basement window exterior – rear, frame damage. Recommend replace/repair.

Window frame damage. Basement window rear. Exterior.

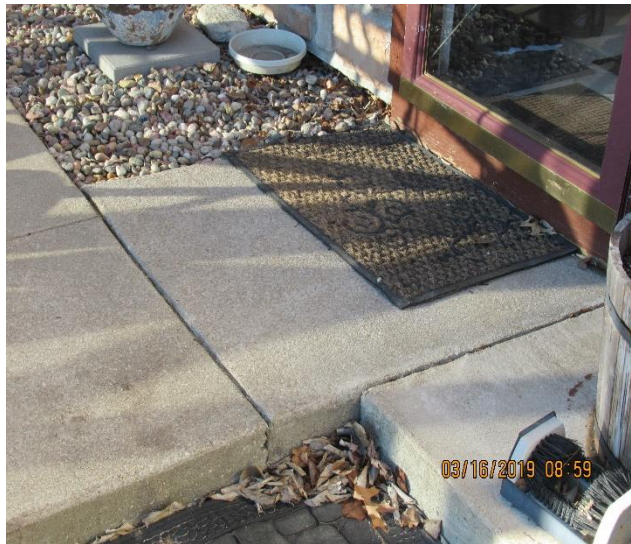
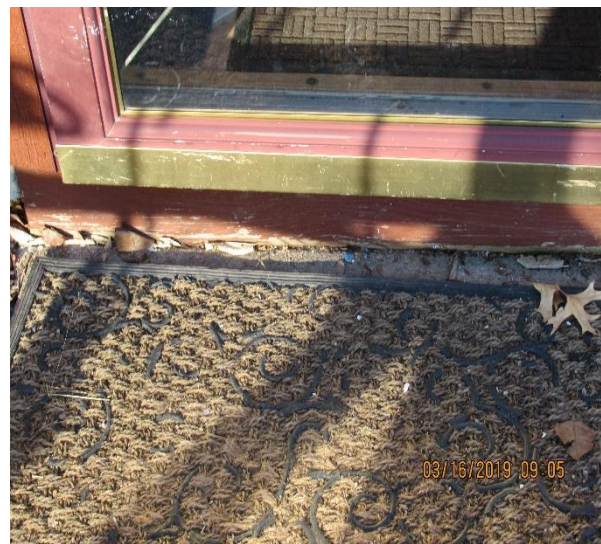
Front entryway – north – concrete step slopes toward the house. This allows water to drain toward the foundation. Recommend repair/replace.

Front entryway – north – concrete step slopes towards the house. Moisture intrusion/wood rot issue.

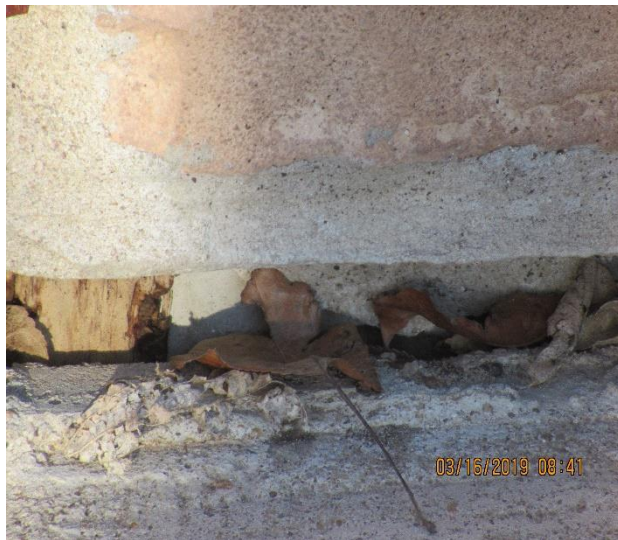
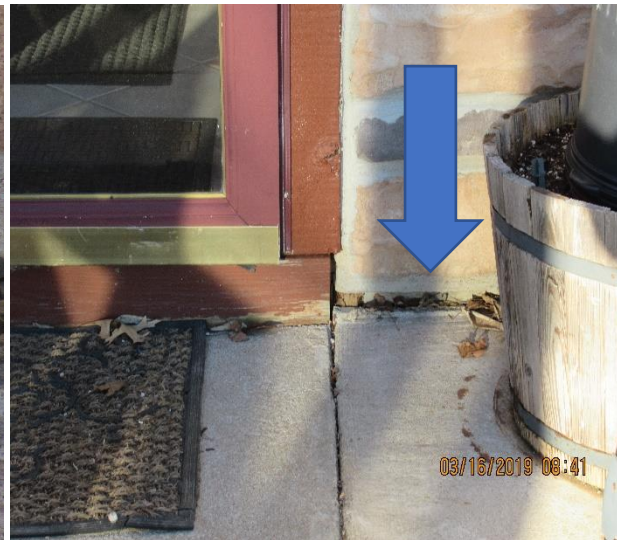
Concrete pad next to front entryway north has a void at the foundation. This allows water to enter next to the foundation. Recommend repair/replace.

Concrete pad next to front entryway north has a void at foundation. Moisture, wood rot issue.

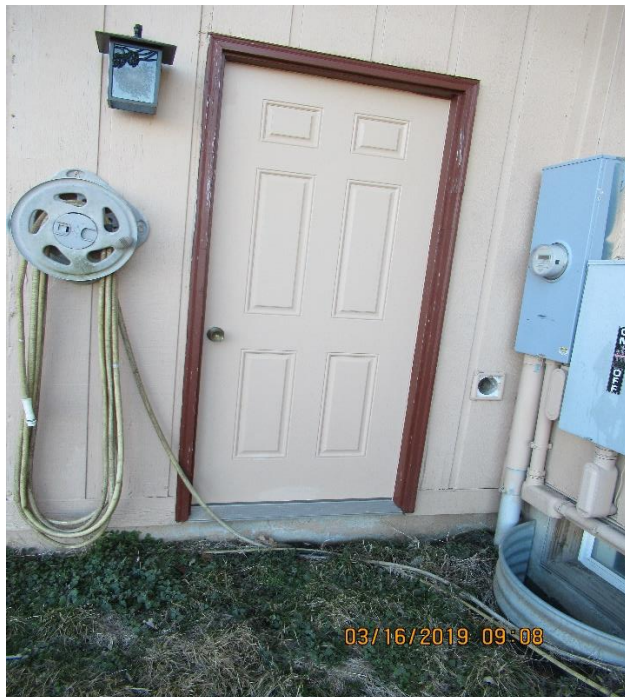
No steps or landing at rear garage door entryway. This is a safety issue, trip hazard.

No steps or landing at rear entry to garage. Trip hazard.

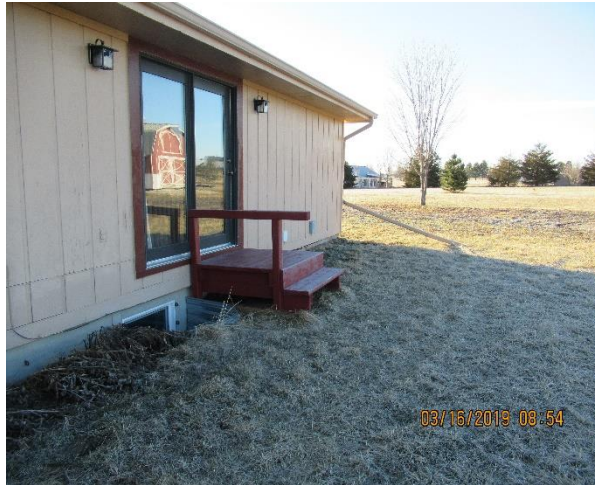
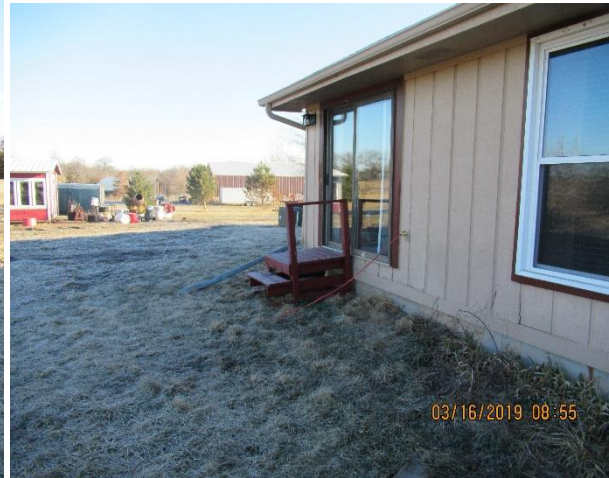
Both rear entry wood stairways at slider door and French door are inadequate. Poorly constructed. Improper railings. Not properly secured. This is a safety issue/hazard.

Both rear entry wood stairways at slider door and French door are inadequate. Poorly constructed. Improper railings. Not properly secured. Safety hazard.

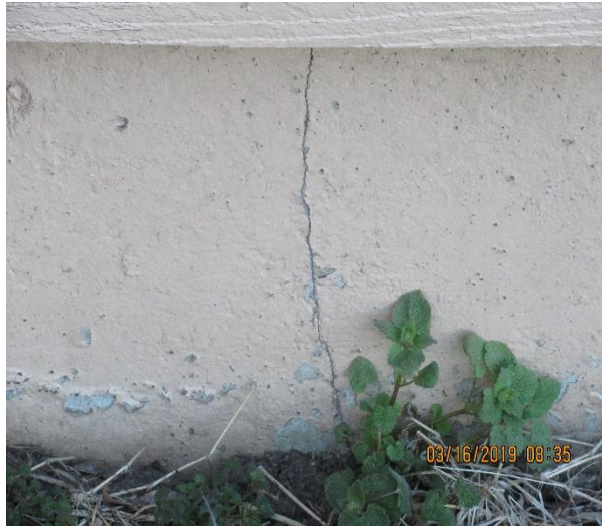
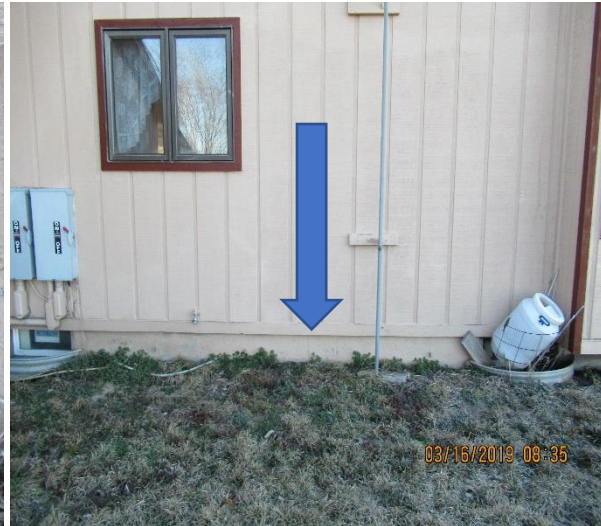
Visible hairline crack in foundation. Although this is common to see in many homes, it is considered a major defect.

As noted before, there is a hairline crack in the north foundation wall. This crack was not visible from the interior.

Visible hairline crack in foundation. North side rear.

Recommend further evaluation by foundation professional.

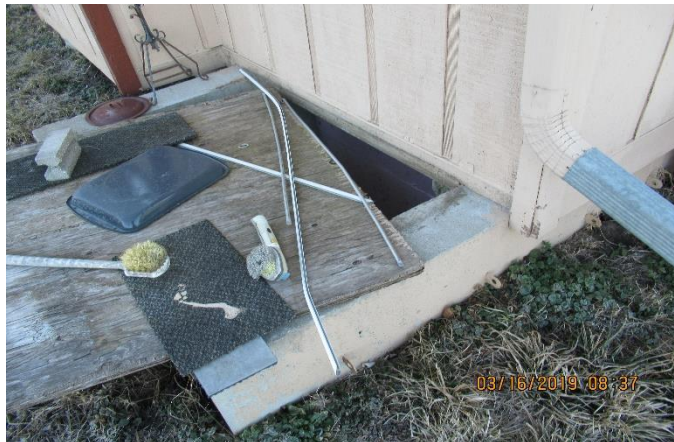
Window wells have no covers. All window wells should have proper covers to keep moisture out. One window well on northwest corner is constructed of concrete. It is covered with a sheet of plywood, and there appears to be no window installed in the “cutout”. Cutout hole is covered by foam insulation. This window “cutout” is covered by a finished wall in the basement. This is a moisture intrusion issue.

Window wells have no covers. Moisture intrusion issue. Window wells should always have a cover to direct water away from the foundation.

One window well on northwest corner, rear, is constructed of concrete. It is covered with a sheet of plywood. Upon further inspection, there appears to be no window installed in the foundation "cutout". Cutout hole is cover with foam insulation. This window "cutout" is covered by a finished wall in the basement. This is a serious moisture intrusion issue.

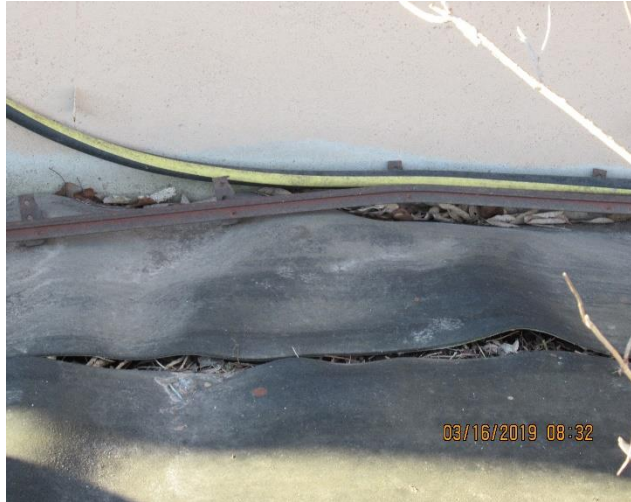
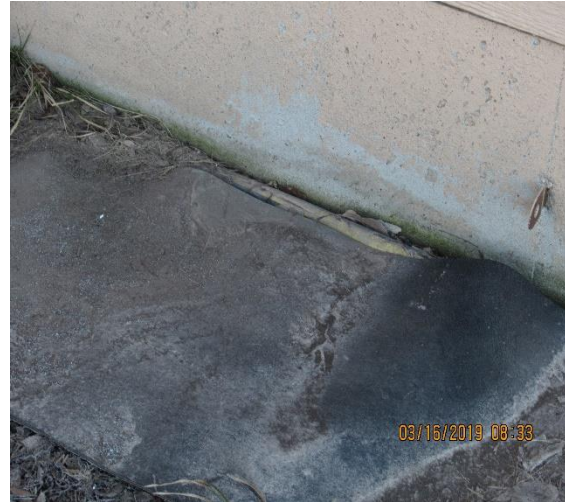
Very poor slope at foundation on north side at garage. There is rubber matting on the ground surface. Water in this area is flowing directly at the foundation. Recommend repair.

Very poor slope at foundation on north side at garage. There appears to be some sort of rubber matting laid out on the ground surface. Water in this area is flowing directly at the foundation. This is a serious moisture intrusion issue.

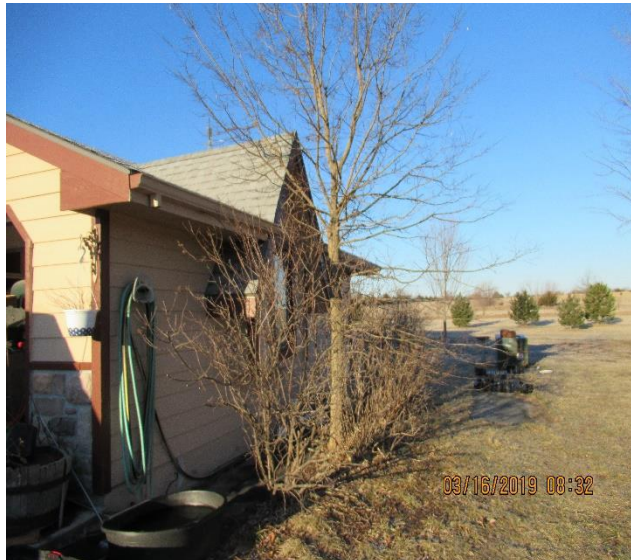
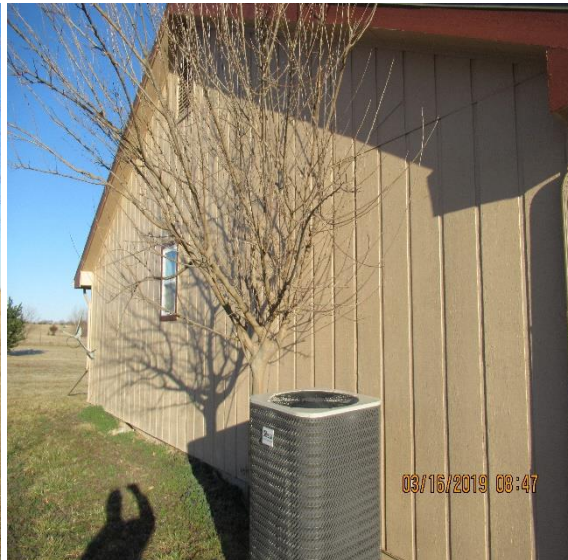
Trees growing much too close to home on north and south sides. Recommend removing these trees promptly as they could cause foundation damage.

Trees allowed to grow much too close to the house on north and south sides. These trees need to be removed promptly, before they cause damage to the foundation.

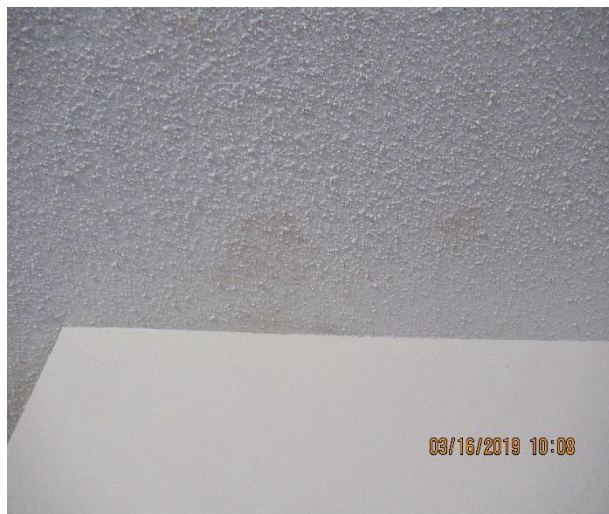
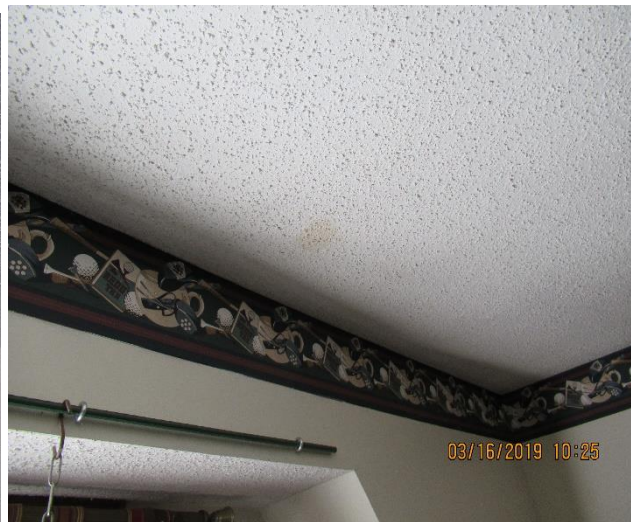
Kitchen ceiling and west bedroom ceiling show signs of previous moisture intrusion. Though these areas tested dry at time of inspection, they should be monitored.

Kitchen ceiling and west bedroom ceiling showed previous moisture intrusion. These areas tested dry at inspection.

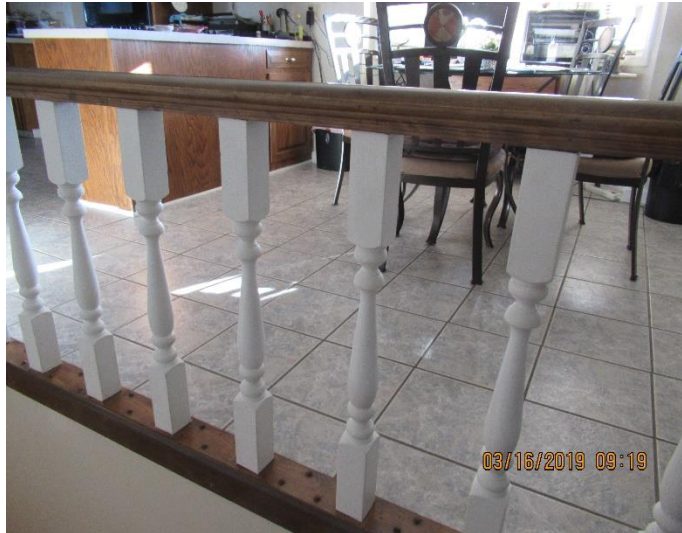
Improper baluster spacing on railing at basement stairs. Balusters should be spaced no more than 4" apart. This is a fall hazard for a small child.

Balusters on railing at basement stairs have improper spacing. Baluster spacing should be no wider than 4" between balusters. This is a fall hazard for a small child.

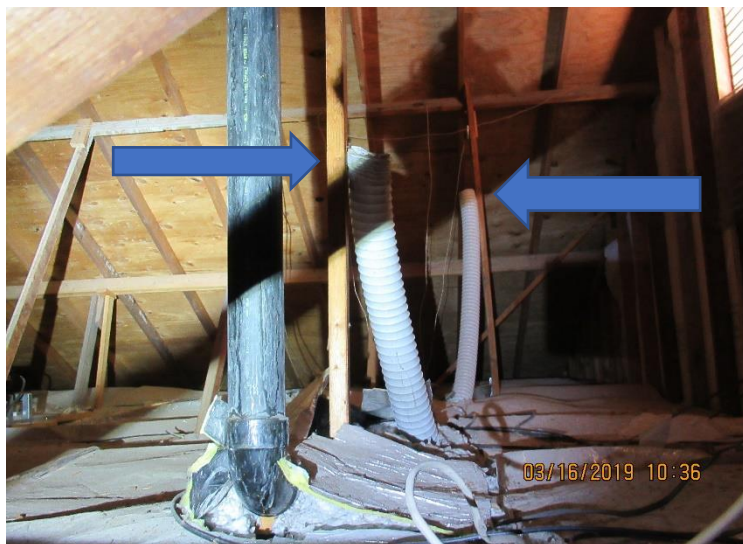
Bathroom vents are vented in to the attic. These vents should extend through the roof.

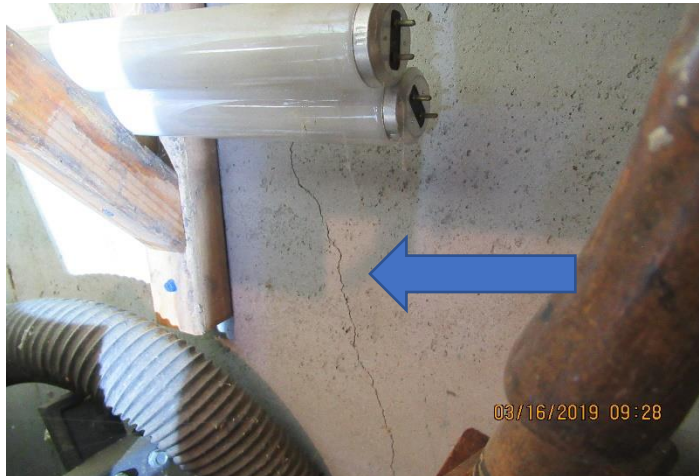
An additional hairline crack is visible from the interior in the "wood shop" area, north of the electrical panel.

An additional hairline crack was visible on an interior foundation wall in the "wood shop" area, north of the electrical panel. This area showed no moisture intrusion at time of inspection.

Although hairline foundation cracks are not uncommon, they are considered a major defect/concern. Recommend further evaluation/repair by professional foundation expert.

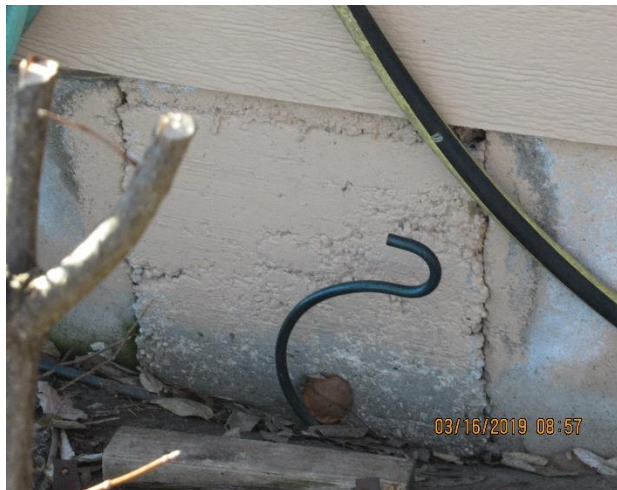
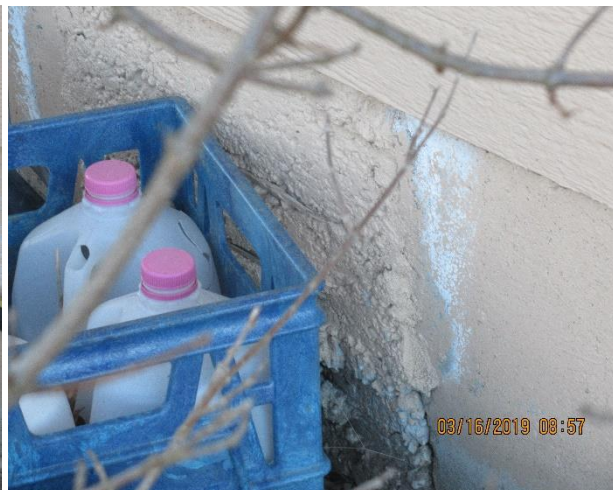
EXTERIOR AT NORTH SIDE OF GARAGE

Several "cutouts" were observed in the top of the foundation walls. These are common to see when a house, or portions of a house are moved from another location and placed on an existing foundation.

Several “cutouts” were observed in the top of the foundation walls. These are common to see when a house, or portions of a house are moved from another location and placed on an existing foundation. The visible cutouts appear to be improperly filled and sealed.

These cutouts appear to be improperly filled and sealed. Recommend further evaluation by foundation professional.

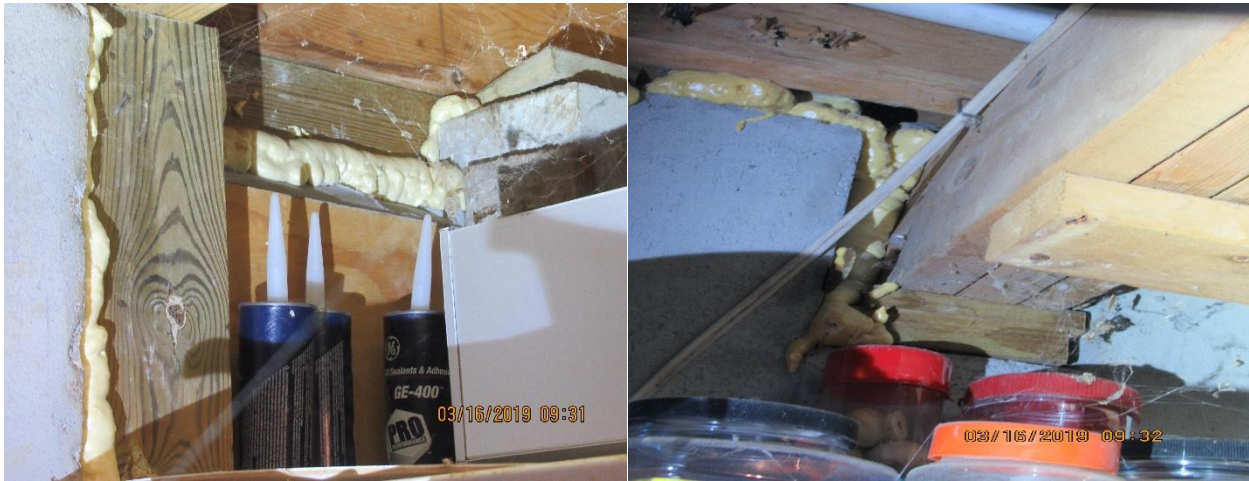
INTERIOR VIEW FROM "WOOD SHOP" AREA

These "cutouts" appear to be improperly filled and sealed.

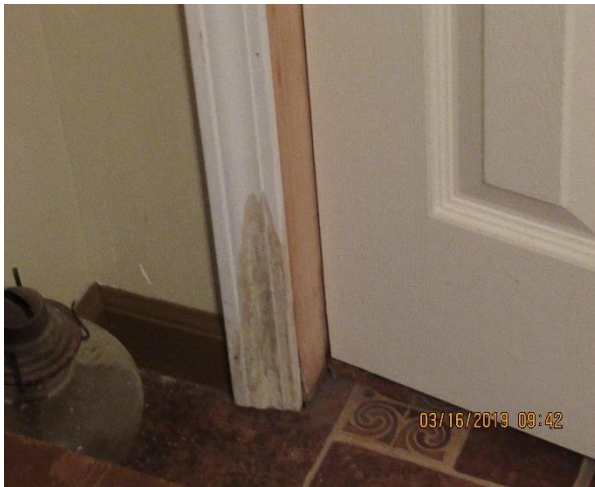
Trim at bottom of closet door in basement shows previous moisture.

Trim at bottom of closet door in basement showed signs of previous moisture.

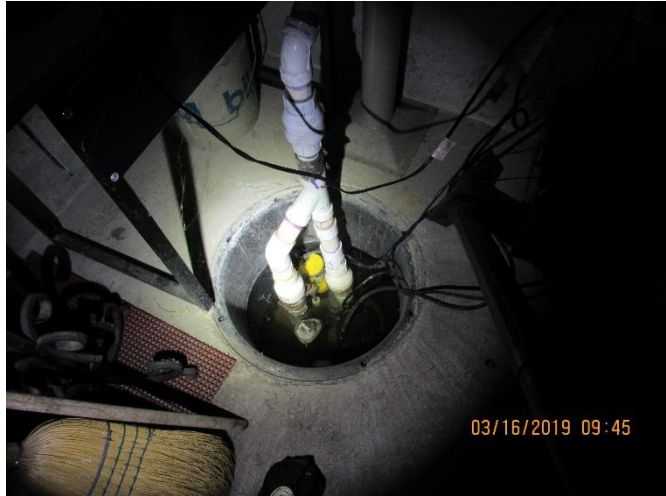
Sump pump tested operational. Pump alarm was malfunctioning at time of inspection. Recommend replacing sump pump with a unit that has a built-in alarm.

-Although the sump pump tested operational, the pump alarm was malfunctioning at time of inspection.

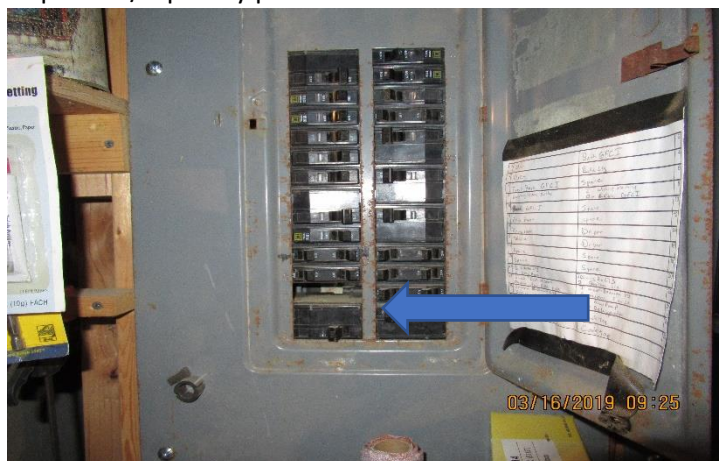
Open breaker "knock out" in main panel breaker cover. Electrical hazard.

-Open breaker “knock out” in main panel breaker cover. This is an electrical hazard. Recommend inspection/repair by professional electrician. Panel door does not shut properly.

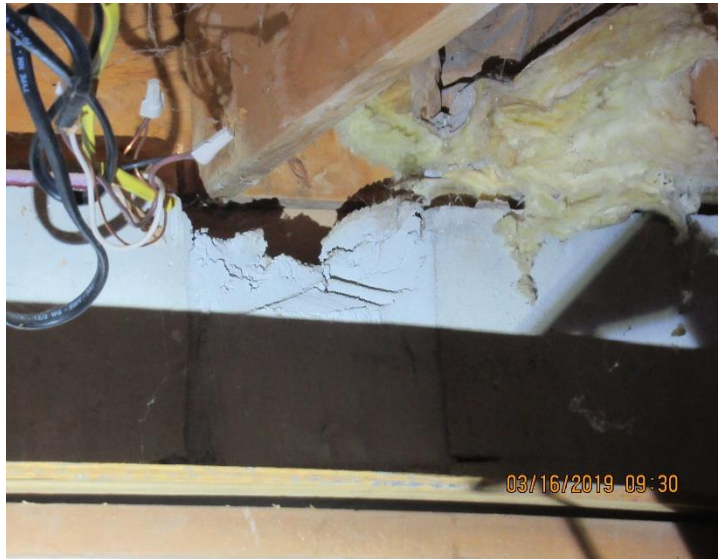
Exposed wiring in ceiling area in "wood shop". This is an electrical hazard.

Open wiring, no junction box. "Wood shop" area. Electrical hazard.

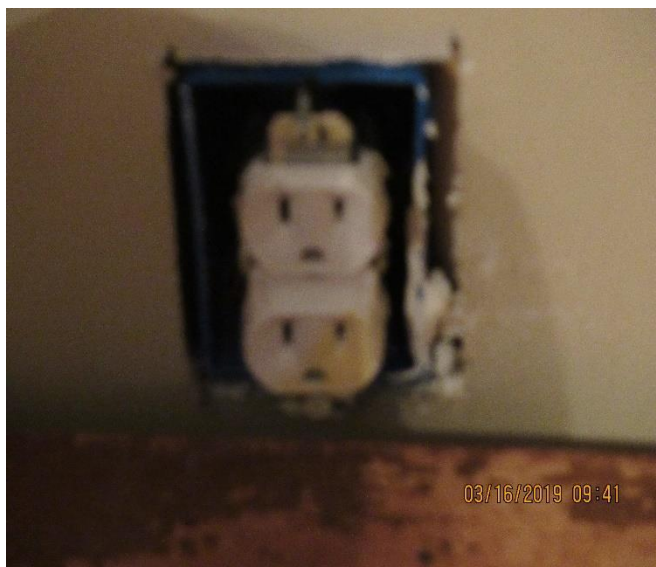
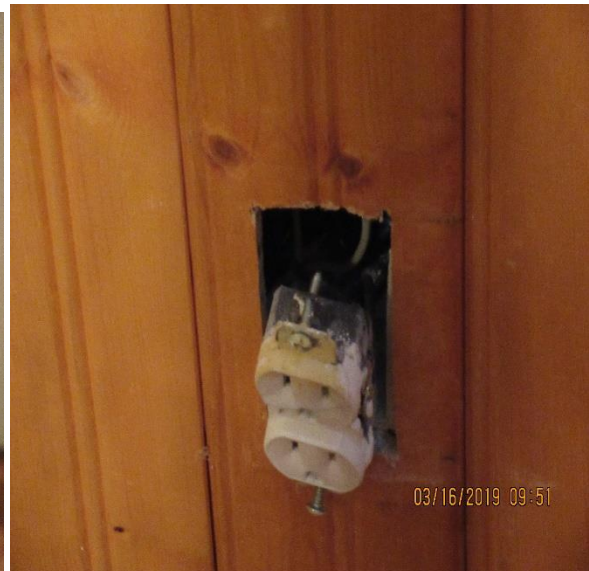
Numerous receptacles in basement not connected to junction box. Hanging loose with no outlet covers. This is an electrical hazard.

Numerous receptacles in basement not connected to junction box. Hanging loose. No covers. Electrical hazard.

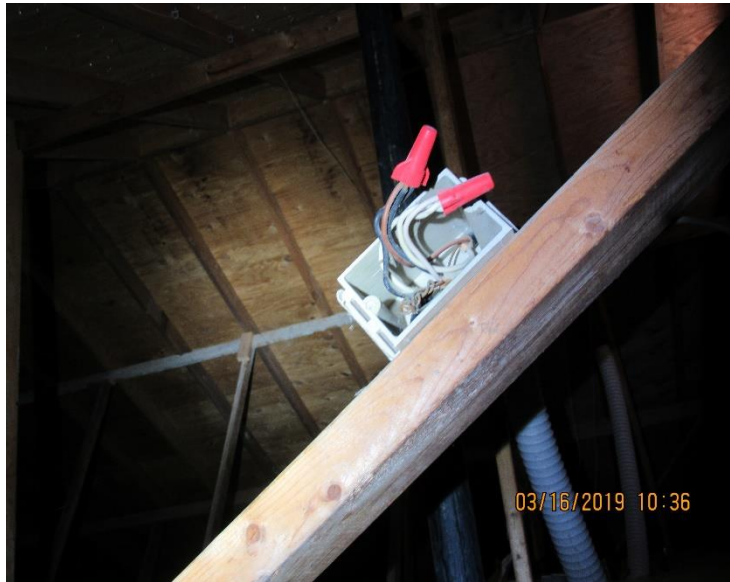
Junction box at attic entrance has no cover. Electrical hazard.

No attic lighting. Safety hazard.

Junction box at attic entrance has no cover. No attic lighting.

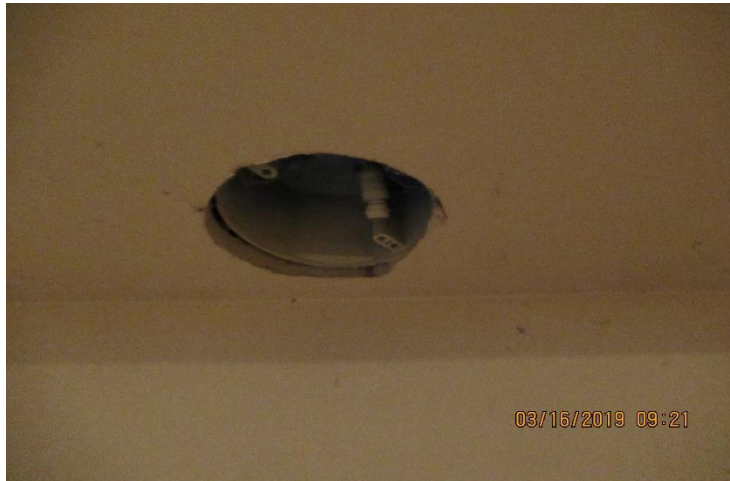
Open light fixture in basement ceiling. Electrical hazard.

Open light fixture. Basement ceiling.
